# NORNER THE POLYMER EXPLORERS

Industry Science Meet-up at UiO

22.11.2017

# Case 1 – Offshore pipe failure

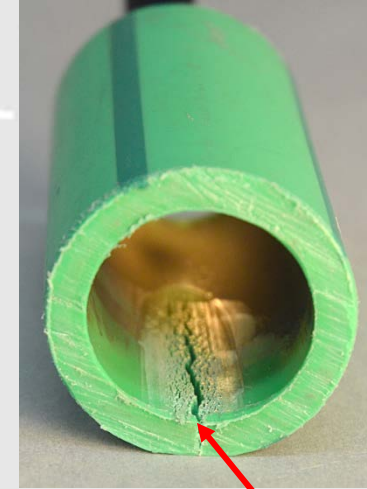
Failure

Material ; PP / PP glas reinforced ( 3 layers )

Material failed after 2 years in service

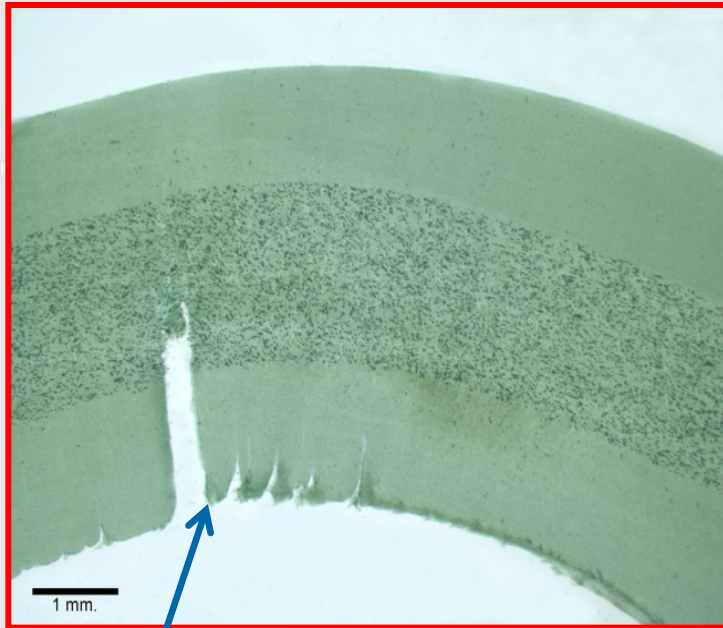
Cross sectional picture

# Case 1 – Failure analyses broken pipe

Main Cause ; Material is severely degraded

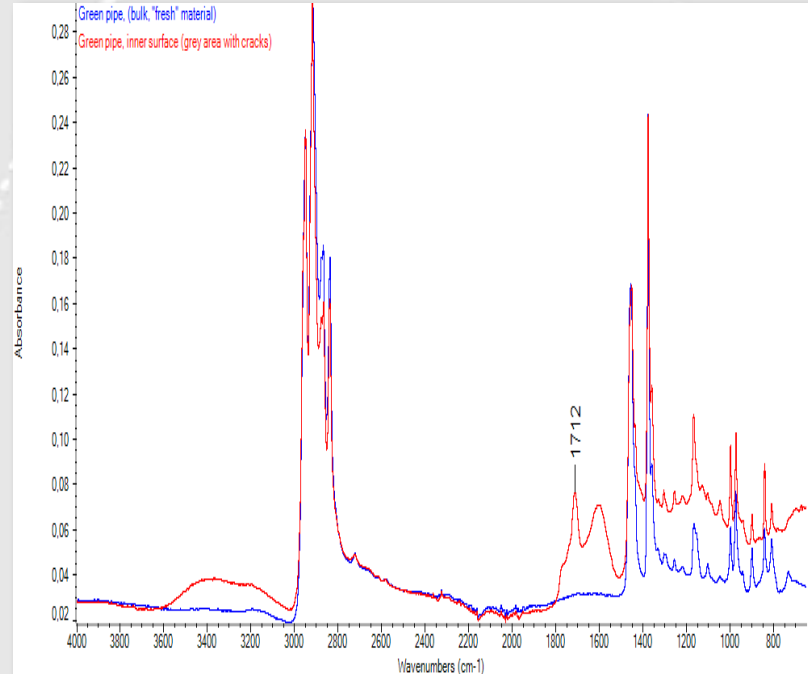
FT-IR; Strong degree of degradation

Solution ; Add metal deactivator to the PP material

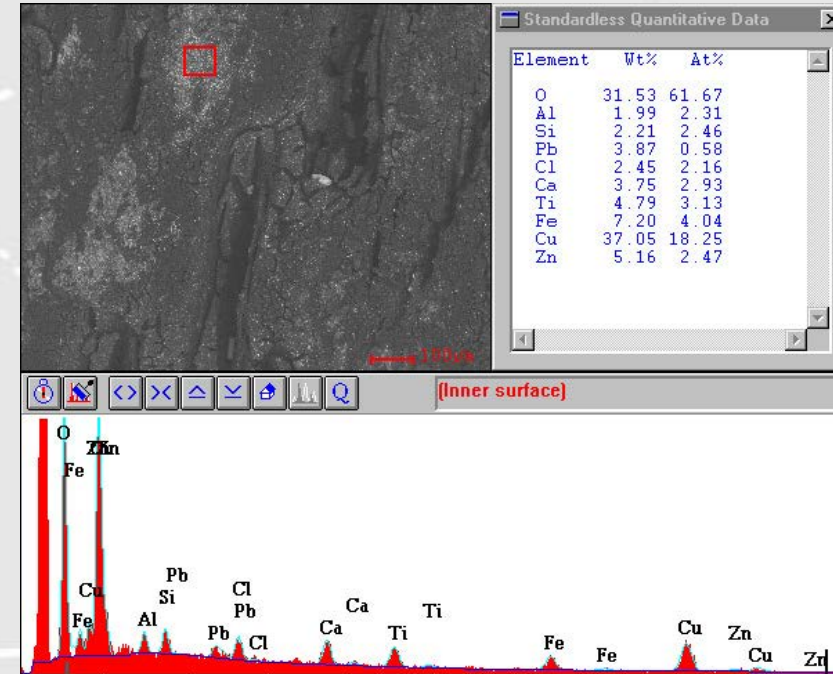
SEM-EDS shows metal, mainly Copper oxide

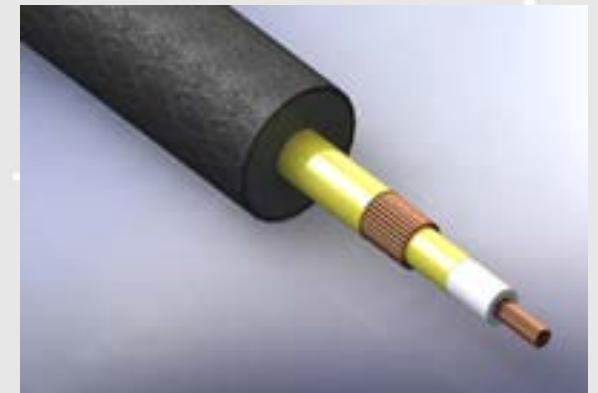
- The ComTrac system, developed by C6 Technologies, utilizes a light-weight, semi-stiff composite rod with electrical cables embedded for communication with downhole tools.
- Well interventions in the most challenging extended operating environments
  - temperature up to 177 °C
  - pressure up to 1 000 bar
  - length up to 10 000 m

Illustration picture;  
Composite rod

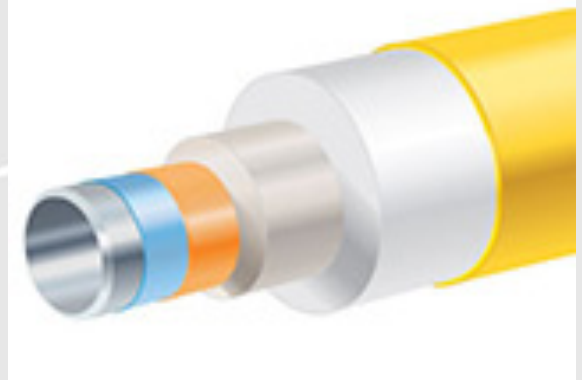
- Thermal insulation is critical in assuring flow in pipeline fluid transport Keeping the temperature of the fluid high avoids solids precipitation and clogging the pipe during production shut downs and towards terminations.
- Maximum temperature rating for insulations on deepwater flowlines is currently 150 °C. Higher temperature insulation is required.
- Project target is 180 °C and 3000 m Seawater depth

Illustration picture;  
Thermal insulation
